Confidential Inspection Report

LOCATED AT: 15082 Homer Rd Fennimore, Wisconsin 53809

Septic Information

Septic Observations

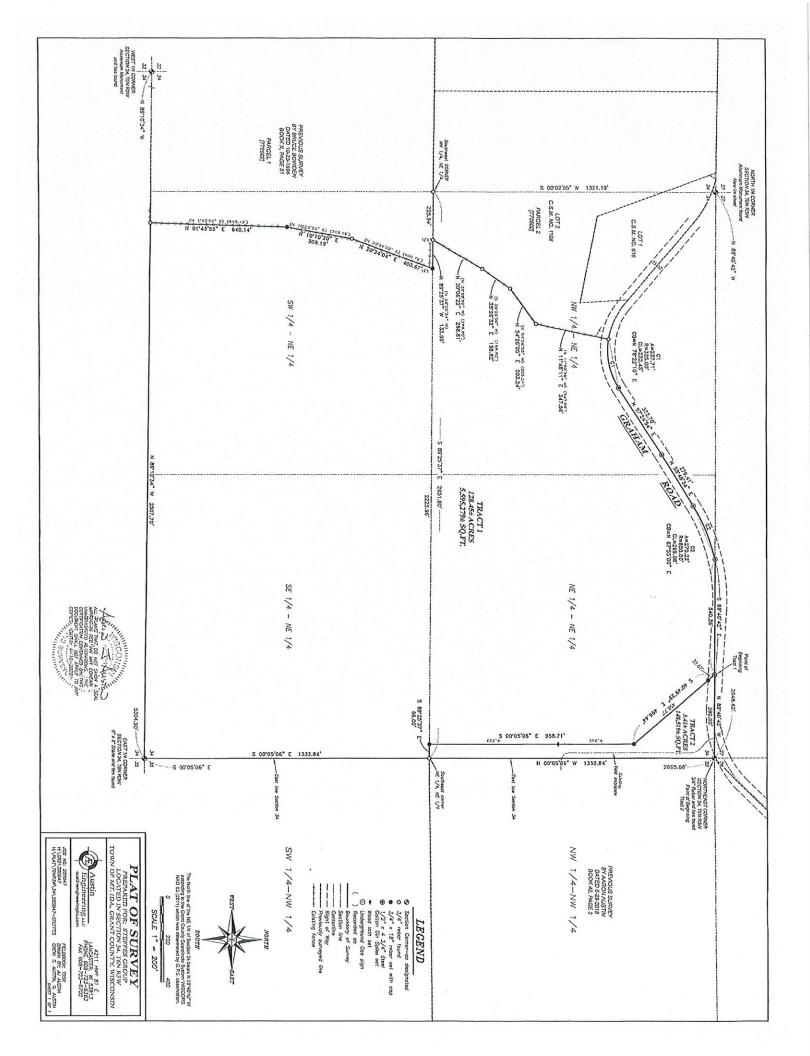
PLAT OF SURVEY

TRACT 1 DESCRIPTION:

That the above descriptions were surveyed, mapped and monumented as shown on this plat by me or under my direct supervision and field work was completed on 4-9-2020.

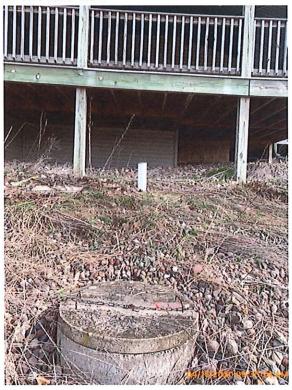
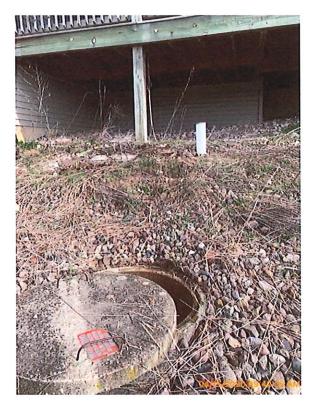
TANK AREA PICTURE

7: The tank view

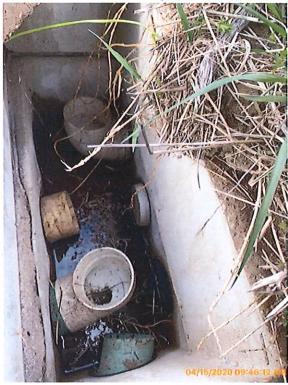
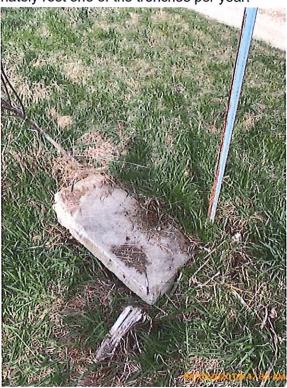
D-BOX

11: Yes; This is called a distribution box because its purpose is to evenly distribute the effluent to each of the trenches. It is normally recommended to alternately rest one of the trenches per year.

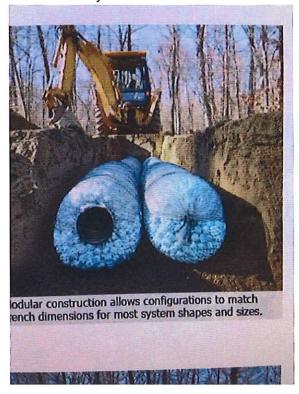
TYPE OF SYSTEM

12: E-Z flow system

13: In-ground non-pressurized

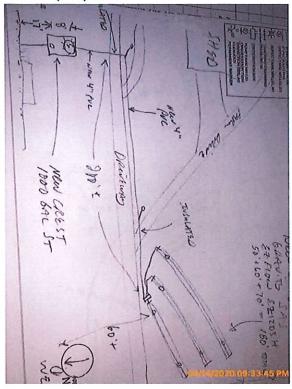
PLOT

19: The plot plan

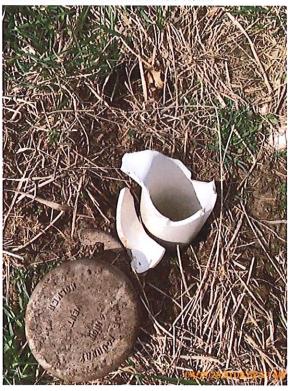
DRAIN FIELD

26: One of the observation vents is damaged. Suggest trimming the top and resetting the cap. This is a minor maintenance item.
